ESTATES MEETING

12TH April 2021

ES83 TREES GREEN LANE

a) Rear of Goldfinch Close

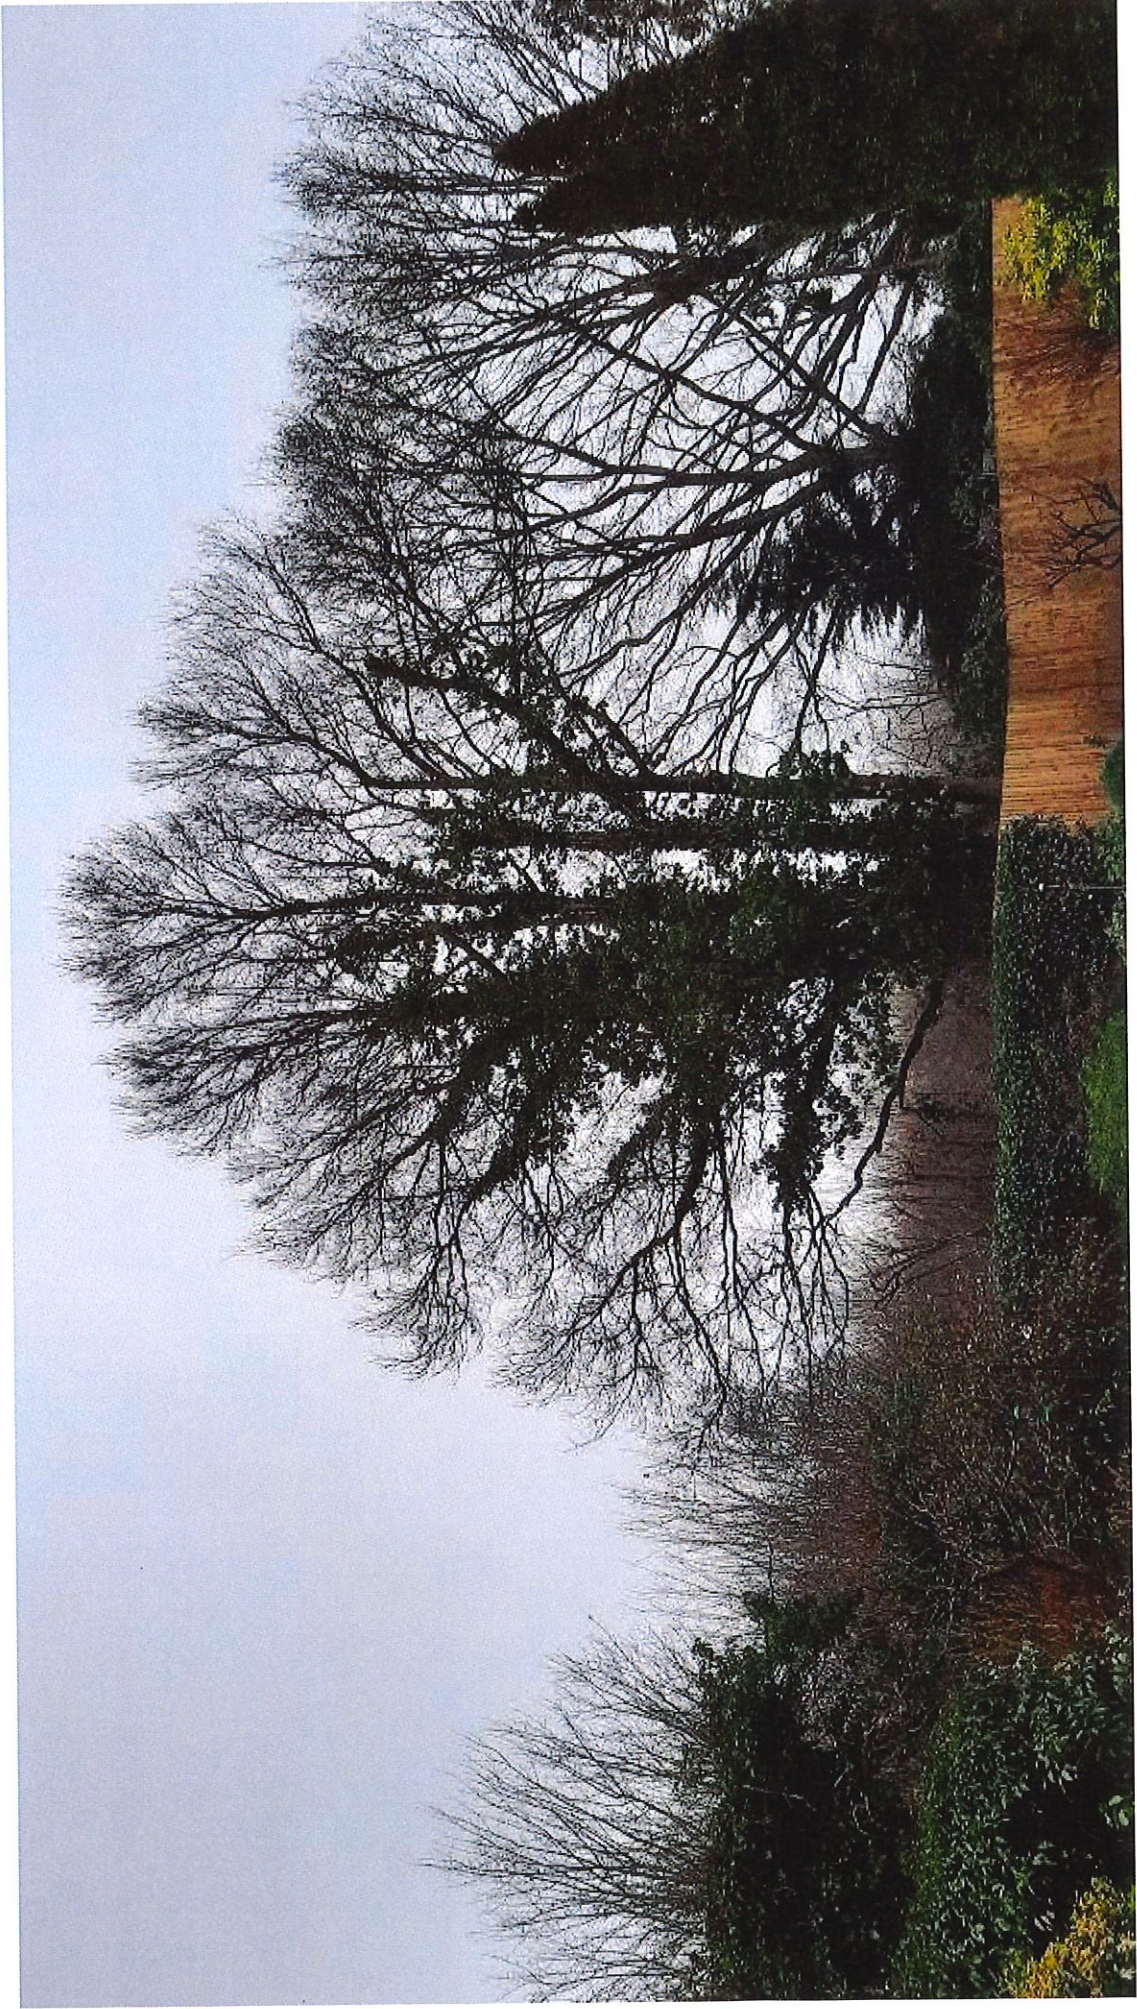
ES 83 (a)

The tree surgeon has visited the site again and his pictures are attached.

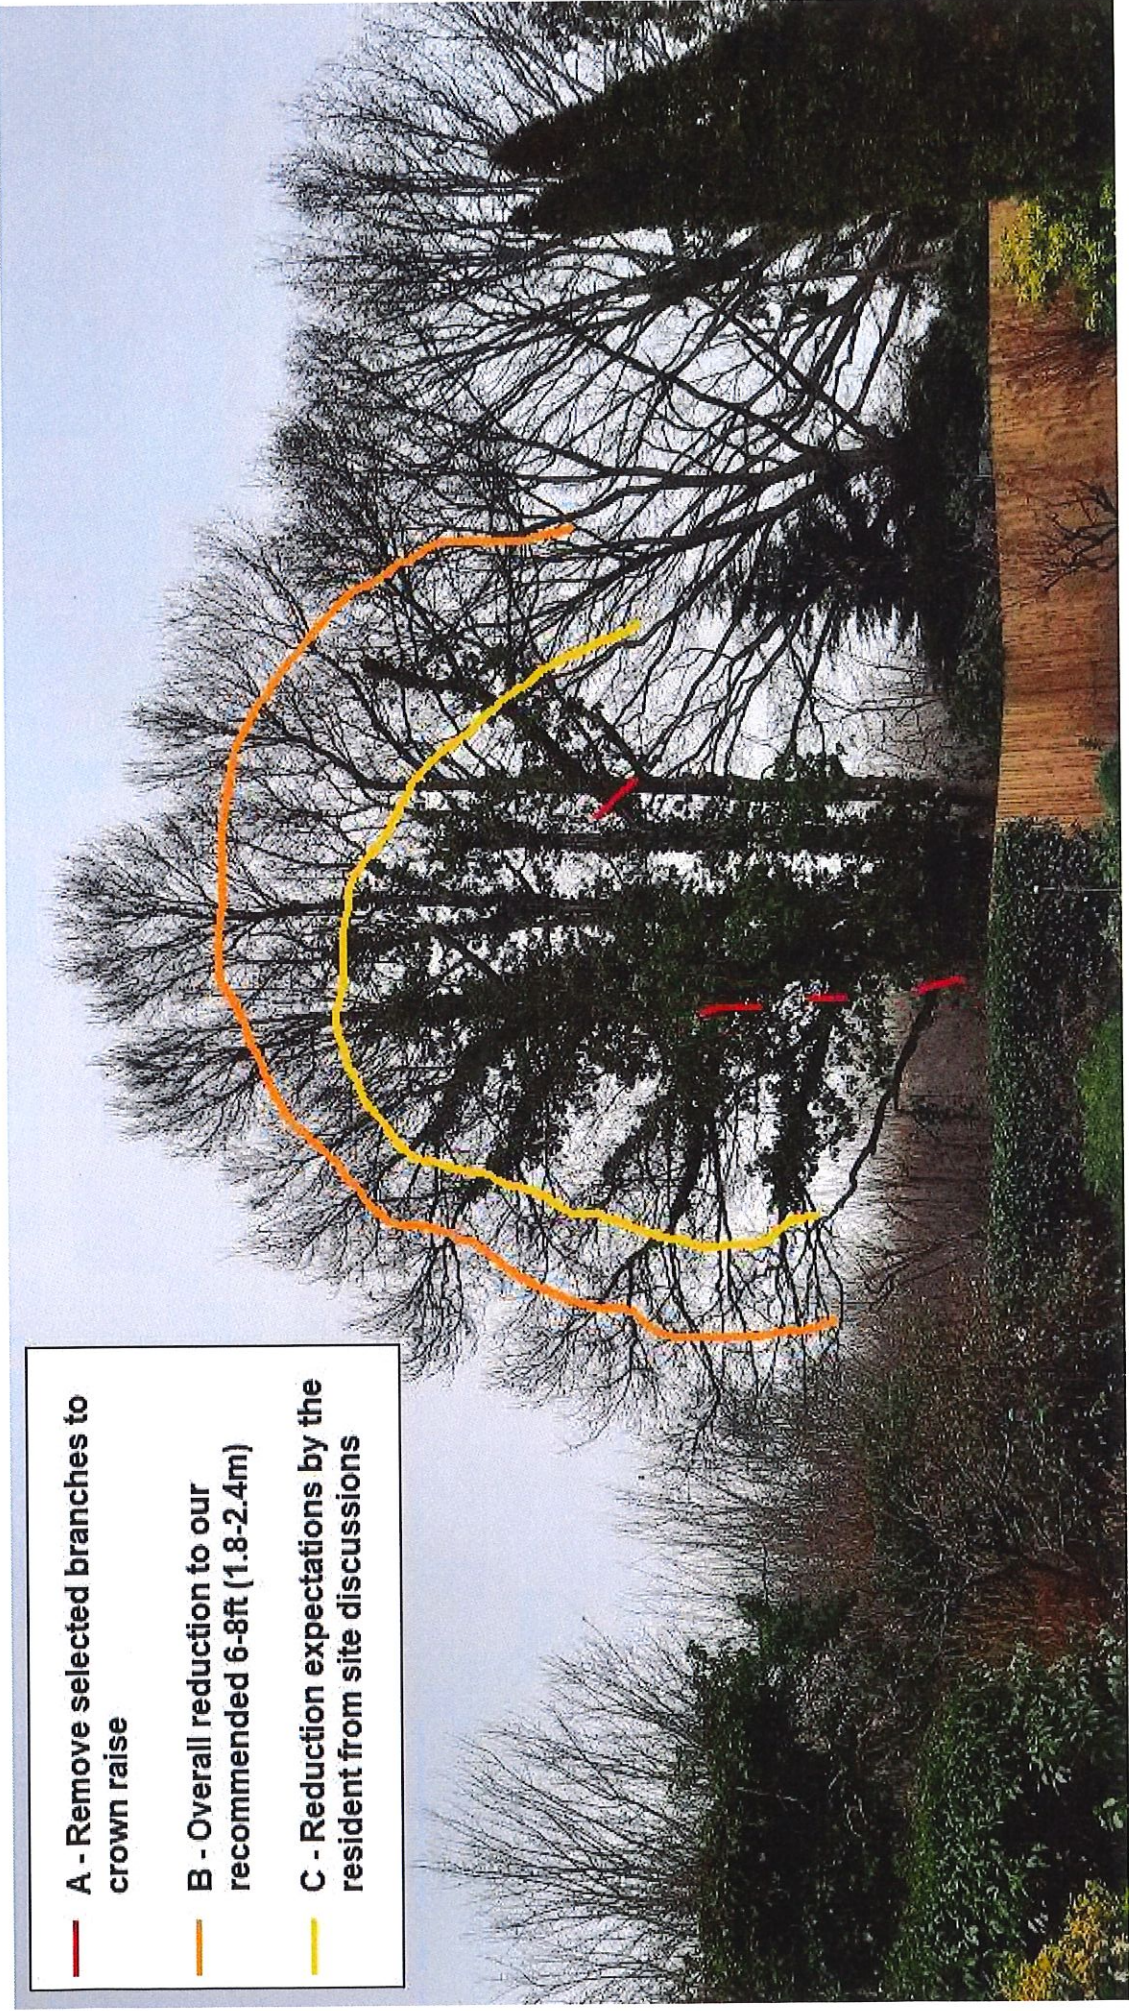
ES 83(a)

The residents garden is directly behind the Oak tree, and they have expressed their wish for more light into the garden. Their patio barely gets any sun in the height of summer. They pointed out when they moved in the tree was significantly smaller and they did used to get some sunlight to that area. They cannot understand why members are opposed to reducing the height of the tree when the trees to the left of their garden, behind their neighbours gardens, have been pollarded to around 15ft (see picture). I suspect some of that work may have been carried out with power networks as those trees are directly under the HV lines above. They do not wish for that extreme level of reduction but would like it to be significant enough to allow for more sunlight and leaf reduction into the patio and garden.

I have edited one of the images to show the options available for the tree. The red lines are selected branches that could be removed to crown raise the tree further without reduction. The orange line is where I would suggest a sympathetic reduction for the tree. The yellow line is more to where the residents are expecting the tree to be reduced to.

A - Remove selected branches to crown raise
-

B - Overall reduction to our recommended 6-8ft (1.8-2.4m)
-

C - Reduction expectations by the resident from site discussions

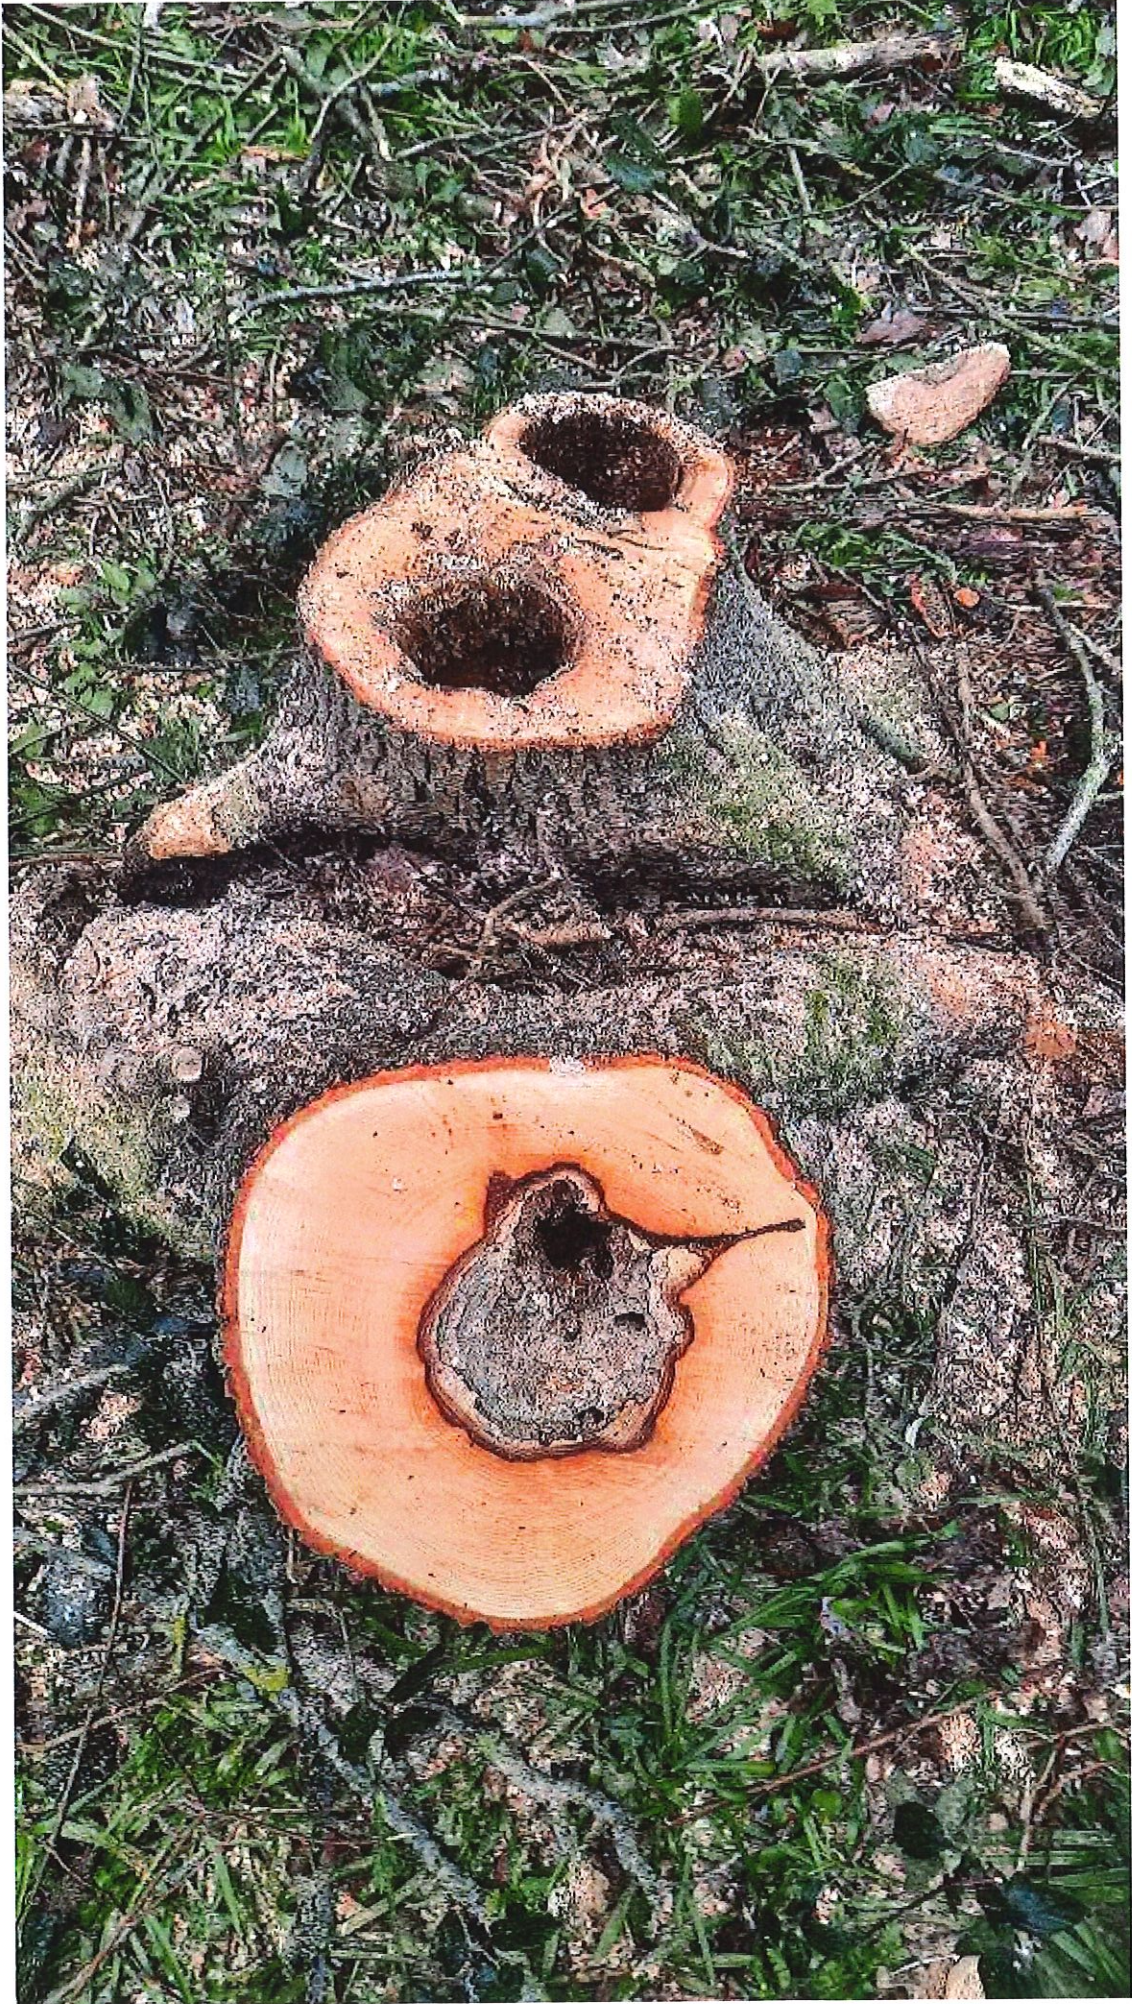
ES 83 (b)

Working with UK Power Networks we successfully and safely removed the problem Ash tree using the spider tracked cherry picker for access. As can be seen from the image attached the tree was extremely compromised with significant rot inside. Huge thanks go out to Matt, Howard and the team from UKPN for their part in this task.
